# Remediated sites and brownfields Success stories in Europe

### 4. Microbiological remediation of soil contaminated with thermo oil in Extremadura, Spain

LOCATION	Extremadura, Spain
POLLUTANT	HTF consisting of biphenyl and biphenyl oxides
SOURCE	Oil accidentally spilt from solar field
GENERAL CLEAN UP OBJECTIVES	Reduce groundwater and soil contamination
REMEDIATION ACTIONS	Excavation, liquid phase extracted with vacuum pumps, waste material stored in 5 compilations, heterotrophic bacteria digestion in ex-situ dynamic biopiles
SITE/END USE	Concentrated solar power station
SOCIAL-LEGAL ISSUES	Land reclamation
KEY LEARNING/ EXPERIENCE TO SHARE	New method tested fo the first time: thermal oil microbiological degradation of biphenyl and biphenyl oxide on site treatment using biopiles

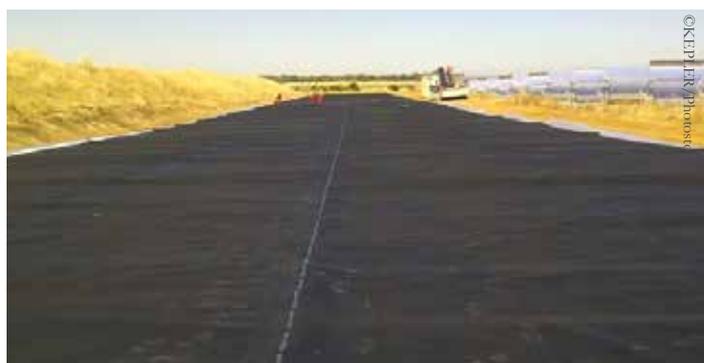
Positioning of the 1.5mm high density polyethylene sheet

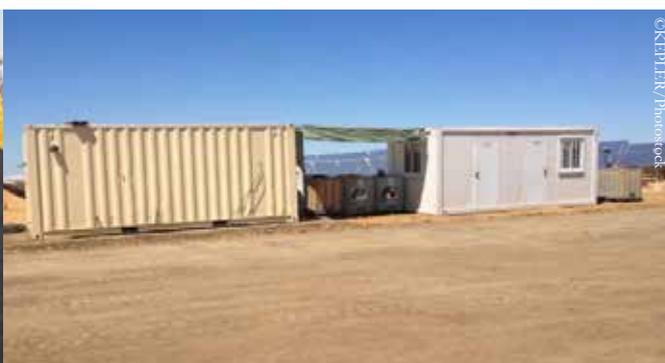
Detail of the plant for soil treatment

Before the excavated material was treated microbiologically, it was stored in 5 compilations which had previously been conditioned and which were isolated by polyethylene tarp. Dimensions and volumes of every single compilation were determined using a topographic survey; also considered was the level of contamination which had been analytically evaluated for each of them. In addition to the conditioning of the excavated material, the base for the construction of the biopiles was prepared. For this purpose an area of 5,430m<sup>2</sup> was levelled and aggregate was spread in two separated zones: one measuring 3,450m<sup>2</sup> and one 750m<sup>2</sup>. Those two zones formed Biopile 1 and Biopile 2 respectively as well as Biopile 3 later on. Within these areas two longitudinal ditches were excavated in order to collect liquids which could possibly leach from the soil treated. The aggregate was then levelled out again as well as compressed. Also a slope of 1% was incorporated in order to ensure that the leaching liquids could be collected in perimetral drains. A geotextile sheet was applied directly on top of the aggregate layer and a double-layer of high density thermally sealed polyethylene (1,5mm thickness) was spread on top of the geotextile. The polyethylene served to make the base of the biopile waterproof. Two tanks of 1,000L capacity were installed at the end of the drainage system to collect the leaching liquids: one for Biopile 1 and the other one for Biopile 2. The leaching liquids were purified using an activated carbon filter and were reused in the plant for biological treatment of soil which was set up next to the biopiles.

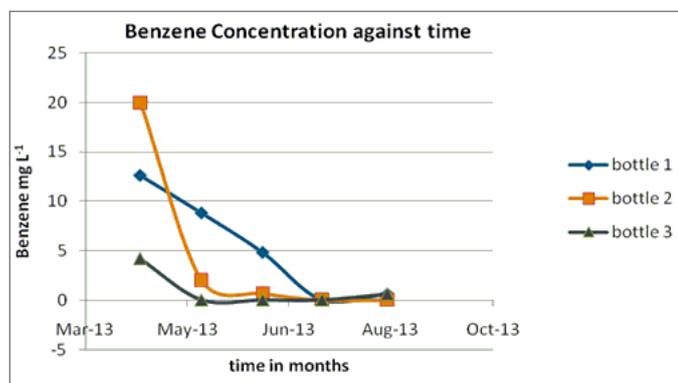
Benzene concentrations during a period of three months

Before beginning the treatment in-situ at the contaminated site, two tests were carried out on laboratory scale. Hence the efficiency of the treatment could be evaluated for the soil in question. Also a possible accumulation of benzene in the ambient air around the biopile during the turning of the soil could be studied. When the microcosms were tested, the degradation of biphenyl and biphenyl oxide against time was proven to be greater when using bio augmentation (degrading microorganisms and nutrients had been added) compared to a sample where the only parameter controlled was the humidity. Tests regarding volatilization allowed specifying the concentration of benzene associated with a contaminated soil sample in conditions simulating the ones in the biopiles. Even though the concentrations determined were below the maximum value specified in the law for prevention of risks at the workplace,

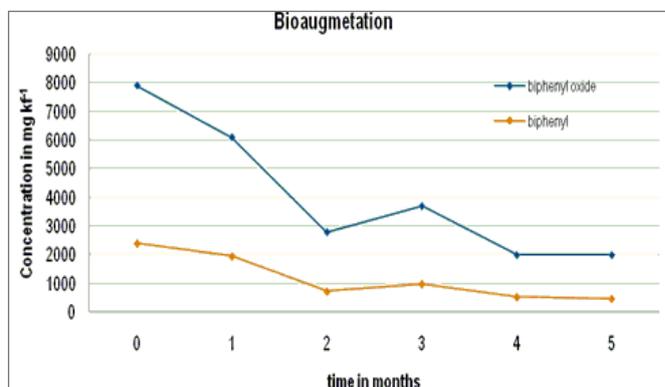
Development of degradation, second tray (biodegradation)

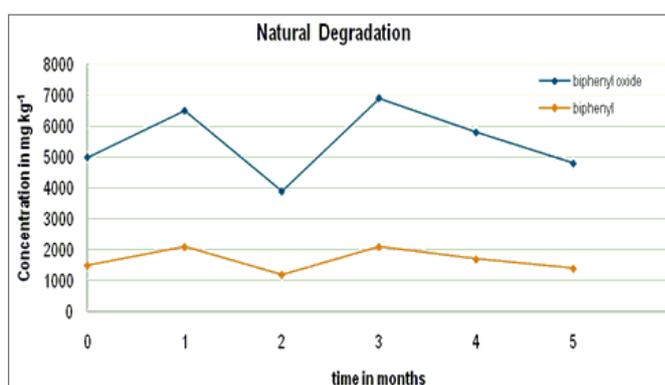
Development of degradation first tray (natural degradation) bmp

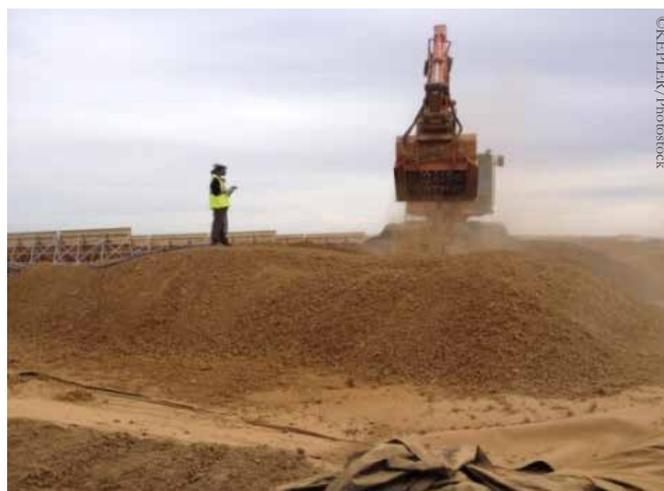
Soil turning and applying of the solution of nutrients and microorganisms.

For carrying out a project using biopiles it is crucial to add sufficient amounts of oxygen. In this specific project, high oxygen levels were maintained by turning the soil with a backhoe equipped with a shovel for crushing and soil-turning. To maximise efficiency and to ensure that the nutrients, the water and the microorganisms would reach every gram of soil, the turning of the soil was carried out while the soil was sprayed with a water and microorganism solution. The needed levels of humidity, oxygen and nutrients were based on regular analysis of samples taken at the biopiles. The quantity of microorganisms added was determined as a function of the concentrations of degrading microbiota and pollution, as well as from the volume of soil to be treated. In order to produce and maintain the microorganisms in perfect conditions, an automatic fermentation plant was installed next to the biopiles. Also mixtures of water and/or nutrients and/or microorganisms could be prepared there and then be used in the biopiles. Once one treatment was finished, the biopiles were covered with thin sheets of polyethylene. This served the purpose of protecting the biopiles from an excess of humidity due to rainfall on the one side and it also prevented the contamination from escaping into the environment on the other side.

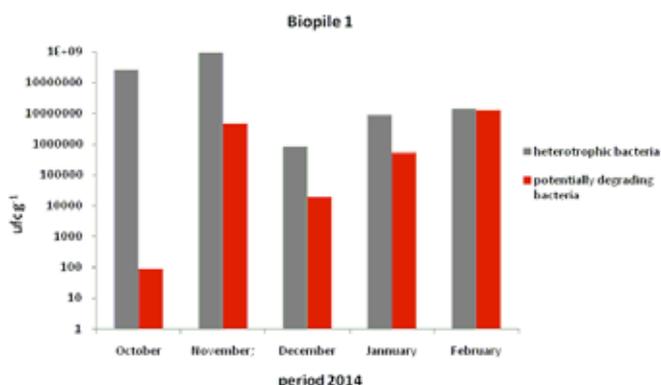
Concentrations of bacteria in biopile 1 over a period of 5 months (ufc g-1).

gram (ufc g<sup>-1</sup>). Considering the concentration of bacteria in biopile 1 during 5 months, it becomes clear that the concentration of microorganisms which are potentially degrading rose as the project went on. This fact points out that the exogenic microorganisms added to the soil during the treatment are capable of adapting to their surroundings and consequently to carry out the biodegradation. The unfolding of the degradation processes in the field (Biopile 1) and in the laboratory tests (microcosm) are illustrated and compared. Clearly the laboratory tests allowed optimizing the treatment in the field in such a way that the results obtained in the biopile were even better than in the laboratory. Once the target values of the microbiological treatment had been reached, an analysis of the toxicity of the recovered soil was carried out by taking two samples per biopile. The biological samples of toxicity are used on a regular basis to evaluate environmental samples. Those tests are based on the natural bioluminescence of a marine bacterium called *Vibrio fischeri* in the presence

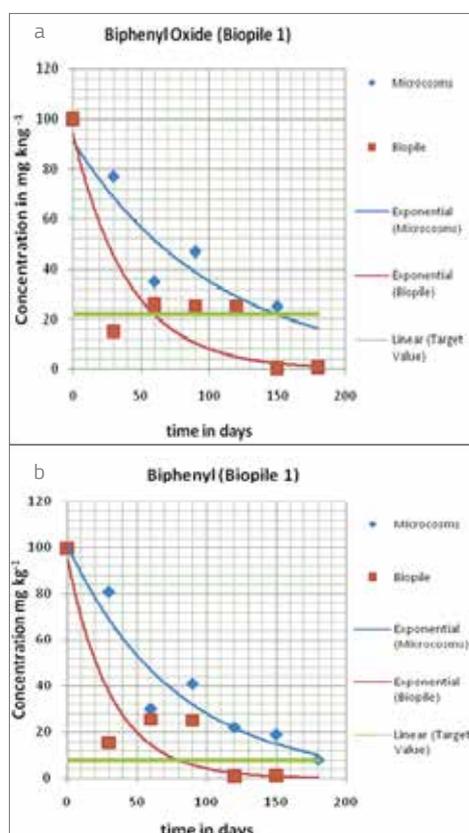
- a) Comparison of the degradation of biphenyl in the laboratory and in the field (percentage of degradation in days of treatment).  
 b) Comparison of the degradation of biphenyl oxide in the laboratory and in the field (percentage of degradation in days of treatment).

oxide has proven to be significant. Those micro-organisms were created in the laboratory of KUVIER and multiplied and maintained at the plant of biological treatment installed at the site. The treatment in-situ has made it possible to recover 4,046m<sup>3</sup> of affected soil in a short time. Hence its disposal could be avoided and an environmental benefit could be achieved. In the project described above a microbiological degradation of thermal oil composed of a mixture of biphenyl and biphenyl oxide has been achieved in an on site treatment by means of biopiles for the first time.
